## Implementing Successful Research

## Durability of Truncated Domes

## Evaluation of Fixed End Bridge Joints

## Prolonging Service Life of Weathering Steel (ASTM A 588) Guardrail

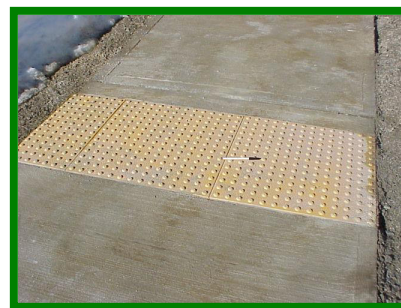
Through the cooperative efforts of several Department Bureaus, this fast-track project was completed during the 2002-03 winter season. Eight truncated dome systems of varying materials and installation methods were installed on fabricated sidewalk panels, which were assembled in January 2002 to create a 229-foot test section. The test section included ramps constructed of anti-freeze concrete currently being evaluated by CRREL. The first winter "season" consisted of 20 plow cycles. The evaluation report was distributed in April 2003.

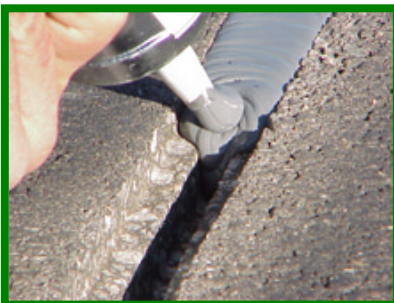
The problem of pavement cracking at the fixed end of bridges has plagued the Department for many years. Pavement cracking appears at the fixed end soon after final paving or resurfacing. Treatment options were evaluated with the goal of implementing a system to control and seal the cracks before they became a maintenance issue.

The project involved locating the fixed end joint of four bridges, creating a sealant reservoir over the joints through the wearing course of the pavement by means of saw cutting, and sealing the reservoir. Each reservoir was sealed with one of four products that are designed to seal pavement cracks. The work was executed by Nicom, Inc. of Barre, VT over the period of October 18 through October 24, 2002.

All of the joints will be monitored for a period of at least two years. At the end of the evaluation period, a determination will be made if any of these products offer a cost effective solution to the problem of pavement cracking at the fixed end joint of bridges.

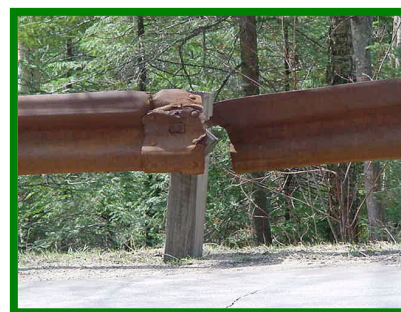
The Department also investigated ways to make the A 588 last longer. Guardrail sections were treated with various corrosion inhibiting and water proofing products and assembled to simulate lap connections. The samples were conditioned for 5000 hours in a 5% salt fog, and evaluated for overall condition. The most effective treatment was

a piece of pure zinc foil shaped to fit between the sections that virtually stopped corrosion from occurring in between the sections. In 2002, language was added to the Standard Specifications requiring the use of zinc inserts at all lap locations. However, the use of zinc can be expected to add 25% or more to the cost of guardrail installations. Because of safety and financial considerations, the Department, with backing from the USFS, will be replacing A 588 with galvanized guardrail, pending further developments in weathering steel technology.

Thought to be more *environmentally blending* in appearance, A 588 guardrail has been installed on National Forest land dating back to the early 70's. However, scenes like the one shown prompted an investigation of the condition of the A 588 guardrail throughout the State. The 1997 report recommended replacement of A 588 with galvanized rail at the end of its functional life.
